Restoration industrial floors

BECOSAN® Report.

The present report is issued in order to clarify individual restoration works mentioned in our quotes. The intention is to provide a more precise description for easier understanding of the surfaces that needs to be refurbished, independently from the priority assigned to the facility.

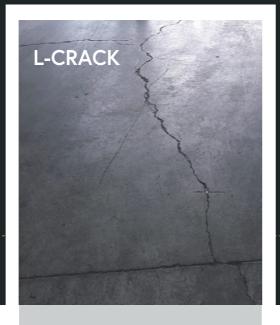
Medium sized crack
(2-9mm) that can be
straight, curved or zigzagshaped. It needs to be
repaired as the existing
crumbling will lead into a
detachment of concrete
parts within the crack. The
consequence will be major
damage of the surface due
to concrete spalling.

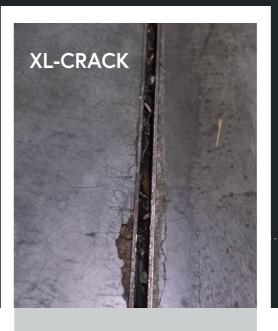
Large crack (≥10mm) that usually appears close to contraction or construction joints. It needs to be repaired as otherwise it will difficult or even make impossible traffic of forklifts, AGV's, etc. It will lead into severe surface erosion of the surface and considerable damage of the concrete floor will be the consequence.

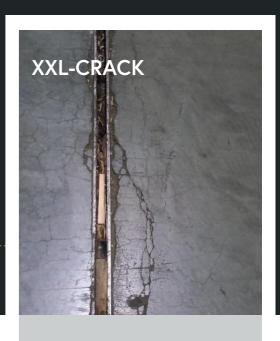
Very large crack (≥30mm) as a consequence of a not timely repaired XL-Crack to prevent further surface damage. These areas are very dangerous as they can cause heavy accidents. Areas with XXL-Cracks should not be used at all in warehouse or logistics operations.

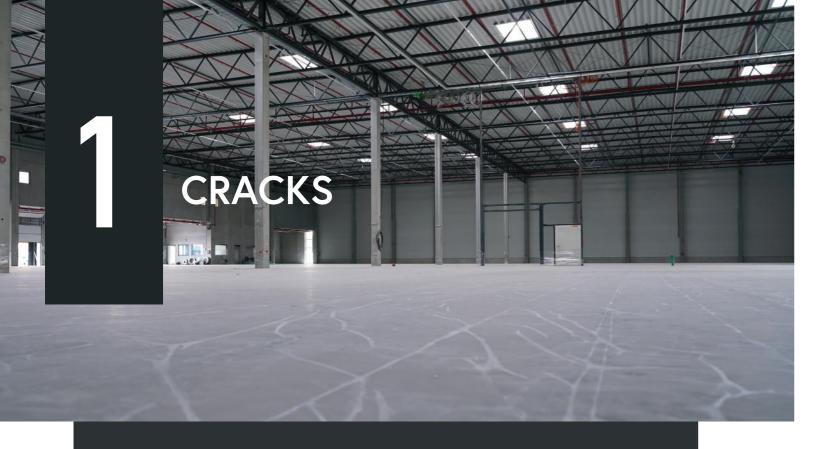
REPAIR OF DIFFERENT CRACKS

Repair works for S-Cracks consist in cleaning on their whole length and filling with BECOSAN® J+C Repair Kit. All other cracks need to be cut vertically prior to the filling with BECOSAN® J+C Repair Kit.

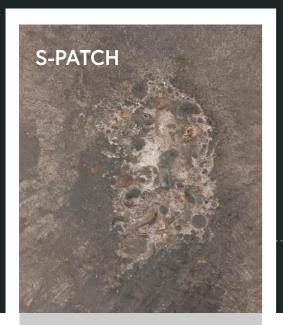
Minor patch (>10X10cm) with different shapes, round or squared. Patches can result from impact of goods on the floor or in areas where large cracks intersect. It makes the traffic of people and machines more difficult grows into a larger patch if not repaired on time.

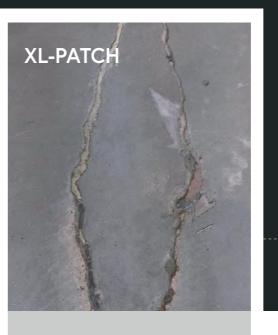
Large patch (>20X20cm) that disallows to use a large area in a warehouse as it is impossible to drive through this area with industrial vehicles.

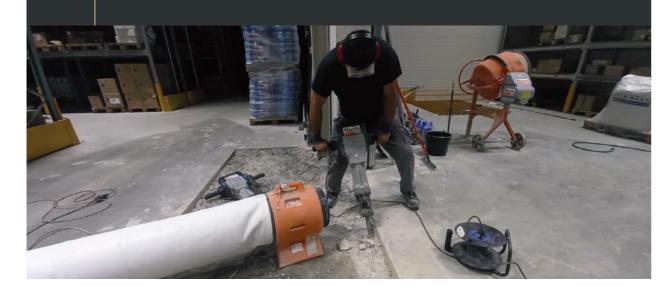
REPAIR OF DIFFERENT PATCHES

Patches are dangerous for industrial vehicles that carry heavy loads, especially if these are carried at major heights. They need to be properly fixed to guarantee a long-term result. Repair works consist in cutting the whole patch area with a certain depth. Subsequently the patch area is sealed with a specific mortar.

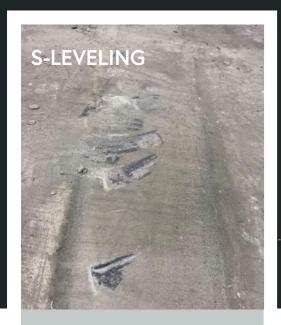
A small unevenness (height difference ≤3mm and grinding width < 10cm) at construction joints or at passage doors that connect 2 warehouses harms industrial vehicles and makes driving of industrial vehicles uncomfortable.

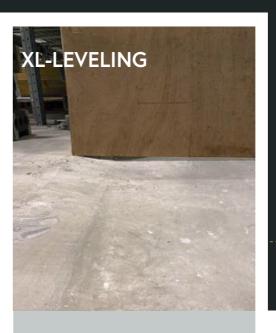
A severe unevenness (height difference > 10mm) causes large cracks and important surface damage due to impact of industrial vehicles into concrete border at the uneven area.

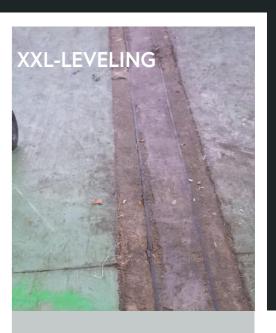
Very heavy unevenness (height difference > 20mm) that in some cases makes it impossible to access the opposite area. Repair works can consist in worst case to cut out and rebuild entire parts of the slab of the affected area.

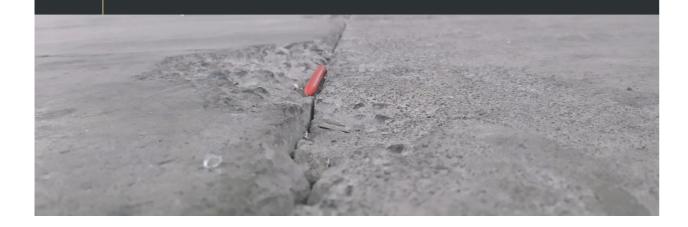
REPAIR OF DIFFERENT LEVELING

Level differences between 2 warehouses or door passages are dangerous for industrial vehicles carrying heavy loads. Some uneven places sometimes are not visible at first view and can cause accidents. Repair works are major interventions. The higher part needs to be lowered on a surface large enough, so that the balance is granted to forklifts, AGV's etc. when passing over them. Repair works consist in lower the concerned are of a slab. Subsequently the treated area is, depending on the size of the area, either grinded or sawed and rebuilt with concrete or mortar to the desired height.

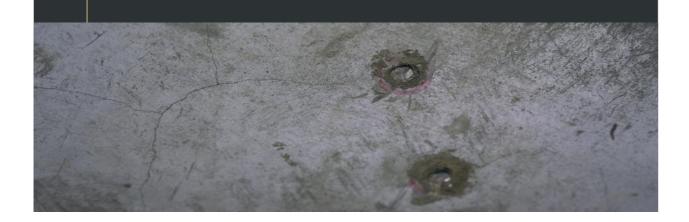
4. BOLT REMOVAL

Bolt from previous racks need to be removed properly should be removed should be removed as they can obstruct the smooth traffic flow of vehicles with rigid wheels. Furthermore, in the event of racking replacement hundreds of bolts are visible on the floor and have a negative impact on aesthetics of a warehouse.

Repair works consist in drilling a hole next to the bolt so that it can be lowered into the floor. Subsequently the hole is sealed with BECOSAN® J+C Repair Kit.

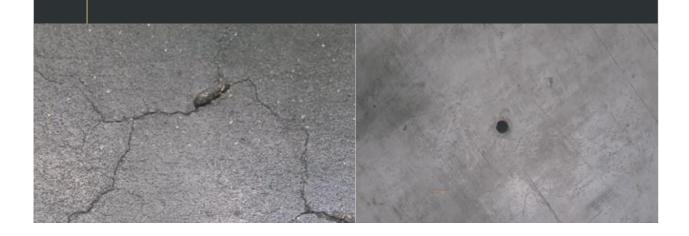
REPAIRING OF HOLES

Holes in concrete floors can result from removed bolts, crumbling due to crazing or objects present in the concrete during pouring (e.g. pieces of wood). They should be repaired as traffic of forklifts, AGV's, etc. could cause further crumbling of the surface and cause major holes. The affected area needs to be clean and dry before filling with BECOSAN® J+C Repair Kit.

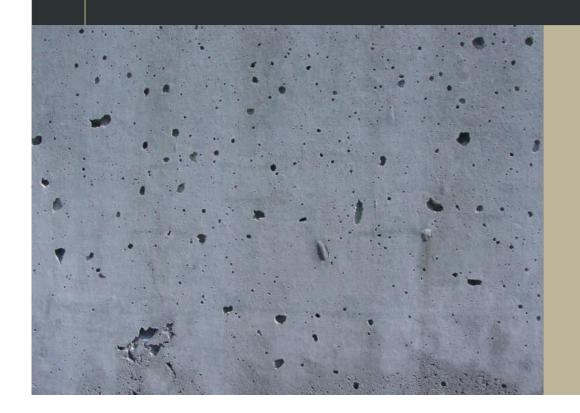
6 GROUTING

Several pin holes due to detached aggregate of due to foreign objects in the upper layer of a concrete floor may difficult smooth trafic with industrial vehicles and lead into major damage if they are not repaired on time
